## HYPERGOLIC PROPELLANTS: THE HANDLING HAZARDS AND LESSONS LEARNED FROM USE

B. Nufer

NASA Kennedy Space Center, Engineering Directorate, Fluids Division, Hypergolic and Hydraulic  
Systems Branch

### ABSTRACT

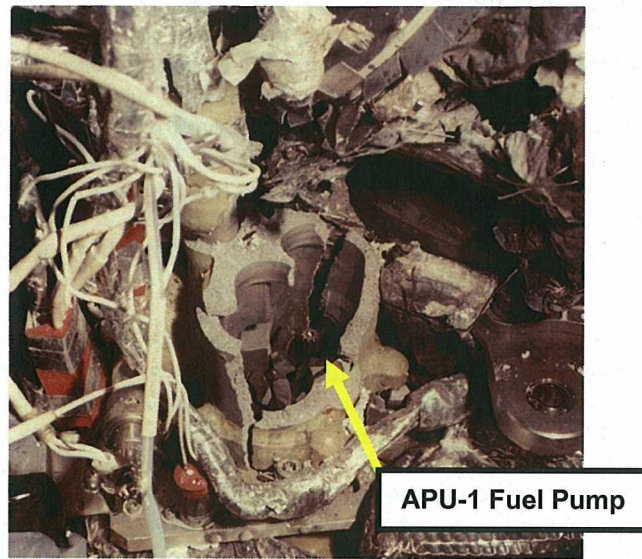
**Figure 18: APU 1 Fuel Pump Explosion Following STS-9**

*The APU failures most probably resulted from a crack in the injector stem caused by corrosion of the sensitized inside diameter surface. The corrodant is probably carbazic acid or some similar substance which can be derived from air, moisture, CO<sub>2</sub>, hydrazine and/or ammonia. The corrosion is time dependent and the crack progressed under sustained stress levels from the inner diameter surface toward the outer diameter surface until mechanical or thermal fatigue conditions could [complete] the crack rupture.”*

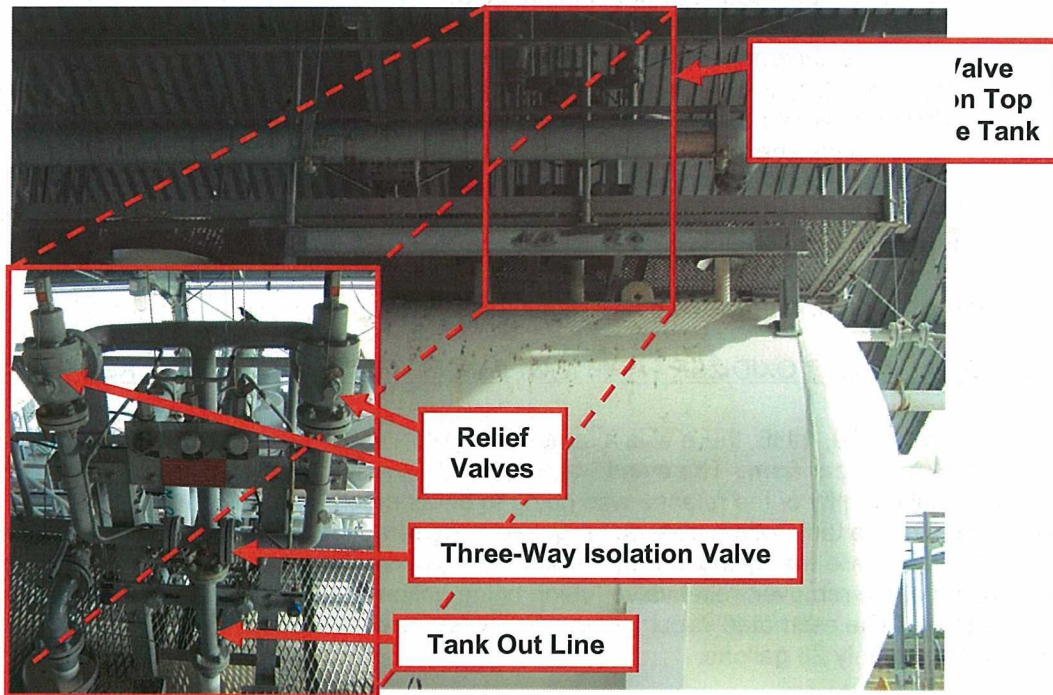
**Figure 23: Dual Relief Valve Modification Location**

An improper GSE design and operational human error were the root causes of this incident. About ten months prior to this relief valve removal and replacement operation, a formal request had been submitted by engineering to install a dual relief valve system onto the storage tank with a three-way isolation valve to prevent a vapor release during component removal. This request was denied. Following the large vapor release, the modification was implemented at both launch pads, greatly reducing the possibility of any future hazard. This dual relief valve modification allowed for isolation during the relief valve annual maintenance. The modification was also implemented on the fuel storage tanks at both launch pads. Figure 23 is a photograph of the relief valve locations on the top of the  $N_2O_4$  storage tank with a close-up photograph of the relief valve three-way isolation valve modification.

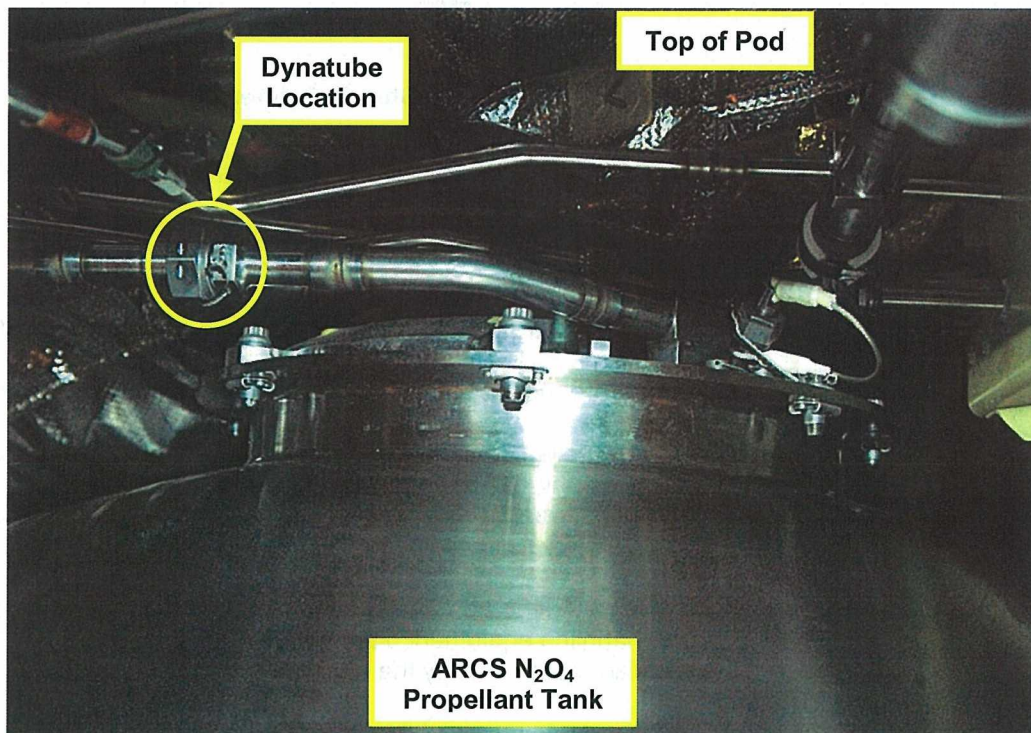
Figure 27: Dynatube Location on ARCS N<sub>2</sub>O<sub>4</sub> Tank

First, the exact location of the leak within the pod had to be found (a cutaway view of the Space Shuttle OMS pod can be seen in Figure 25). This was difficult because the internals of the aft pods and forward module are not meant to be accessed while the vehicle is at the launch pad. The location of the leak had been isolated to the LRCS  $N_2O_4$  system or the associated tubing through monitoring of the instrumentation in the LCC. The leak was measured to be 0.26 psi per hour (about 800 standard cubic centimeters per hour) and a TVC found the concentration of  $NO_2$  vapor to be 15 ppm at the vehicle vent door. This later decreased to 3 ppm. An access door was removed on the pod's outer skin and several internal thermal blankets were removed. A long section of PVC pipe was then inserted into the pod to function as a guide for a borescope. Using a borescope, the leak was finally isolated (after a six hour search) to a ½-inch dynatube fitting on the MD224 leg (the  $N_2O_4$  propellant tank ullage vent). A cross-section view of a dynatube is shown in Figure 26 and a photograph of the leak location can be seen in Figure 27.

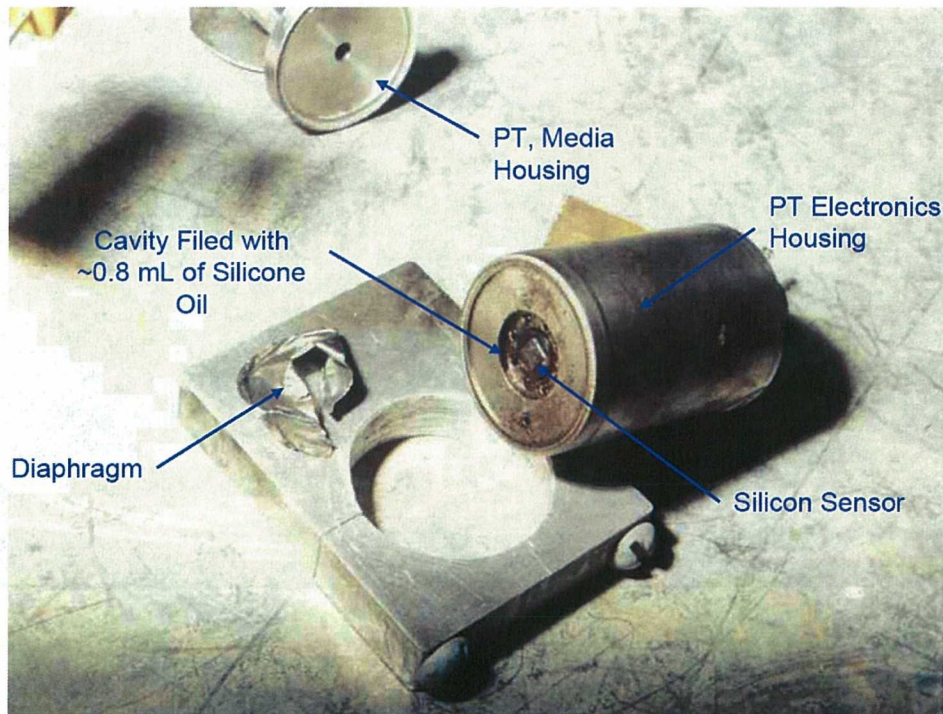
**Figure 46: Failed Pressure Transducer**

Initial inspections of the pressure transducer indicated that the transducer failed as a result of one of the following: over-pressurization, inadequate design, or cyclic fatigue at a highly stressed location. Since the pressure transducer failed, data from it at around the time of the failure may be suspect; therefore, the investigation included a detailed inspection of the nearby system tubing to determine if there was an over-pressurization event. Close inspection of the pressure transducer itself would indicate if the transducer failed from cyclic fatigue or was subject to a ductile failure from a single overload event.

The presence of the silicone oil was not mentioned in the pressure transducer specification from the manufacturer. This is the case for many pressure transducers of this specific design. Close scrutiny of specifications during hypergol component procurement is extremely important. This incident was difficult to prevent since the WSTF personnel did not know that there was silicone oil in the pressure transducer, but an improper GSE design (component procurement) is designated as the root cause. The wind corridor was also assessed and, as a result of this incident, it was altered to reduce the risk to the surrounding buildings from an oxidizer vapor release.
