## HYPERGOLIC PROPELLANTS: THE HANDLING HAZARDS AND LESSONS LEARNED FROM USE

B. Nufer

NASA Kennedy Space Center, Engineering Directorate, Fluids Division, Hypergolic and Hydraulic  
Systems Branch

### ABSTRACT

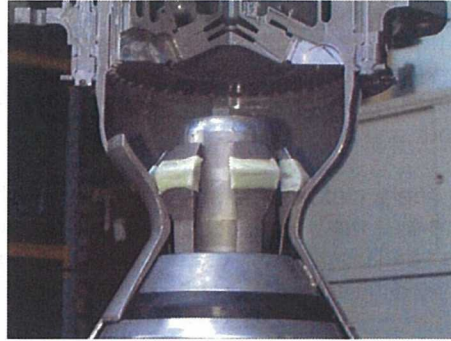
**Figure 20: Space Shuttle Thruster Chamber Cutaway with Purge Adapter Installed**

On May 24, 1985, while preparing for the removal of R4D (down-firing thruster on the Space Shuttle right pod) from OV-099, there was an MMH spill in OPF1 on the 10-foot level west side. R4D was being removed as a result of an in-flight anomaly related to a heater failure on the thruster. The manifold had been drained of its propellant and it was thought that a purge through the MD348 line (which connects to the manifold) and out the thruster nozzle purge adapter was sufficient to remove the liquid and most of the fuel vapors. Figure 20 shows a purge adapter in a cutaway of a primary thruster nozzle. During the part of the procedure where the purge adapter was being removed, approximately one cup of liquid MMH spilled from the thruster and down onto the body flap (which is illustrated relative to thruster R4D in Figure 21). The body flap was partially covered with spill protection sheets. The OPF1 hypergol exhaust fans were activated and the facility was immediately evacuated. It was recorded that some of the liquid MMH had saturated the body flap tile filler bar. It is unknown if the tile had to be removed. Unlike N<sub>2</sub>O<sub>4</sub>, which was known to breakdown Koropon primer (from the STS-2 N<sub>2</sub>O<sub>4</sub> spill mentioned previously), the effect of MMH on Koropon was not well known in 1985.

There are three possible proximate causes to this spill. A combination of two or more of the following causes is also possible. The first involves an improper configuration in which the flexhose that was being used for the procedure had previously been utilized for a similar operation on the left pod thruster L1U's manifold. This flexhose was several feet longer than the flexhose that was normally used for the right pod manifold evacuations. It was routed from the R4D thruster purge adapter to the 19-foot level above, then down to the eductor on the 10-foot level. This excessive length in hose may have allowed for a "u-shaped" low point trap to be formed in which liquid MMH could have collected. The second possible proximate cause involved a procedural error made by the engineers on console. The evacuation could have created a pressure differential across the liquid MMH. When the eductor was deactivated and removed, this pressure differential may have pushed the liquid into the thruster chamber. The third possible proximate cause was the liquid had collected in the thruster chamber (see Figure 20) and the purge was of insufficient duration to remove all the liquid MMH or the liquid trap may have

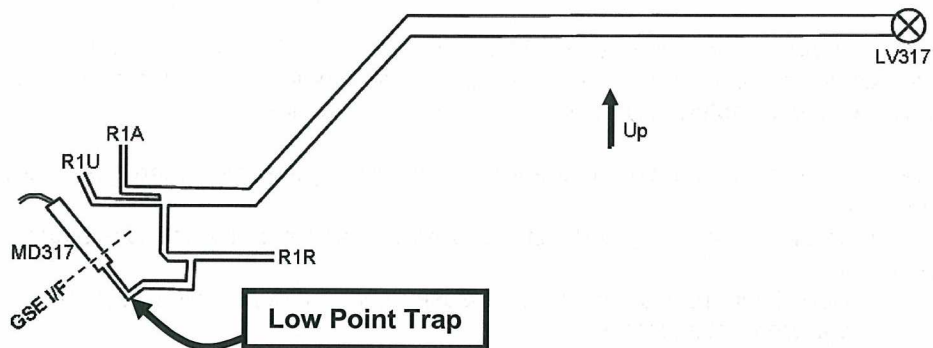
**Figure 36: Approximate Manifold 1 Layout Schematic**

Another possible scenario (not included in the formal mishap report) for the pressure increase was put forth stating the pulse purges were unable to remove all the liquid MMH as a result of a low point trap present in the manifold near the MD317 (manifold 1 drain/purge QD) AHC interface. Figure 36 shows the basic layout and low point in fuel manifold 1 in the right pod stinger area. It is believed that during the purge, gas was unable to enter the line through the MD317 QD to displace the liquid MMH out of the manifold. This was a result of a small bubble that had formed in the low point as a result of helium coming out of the liquid MMH/helium solution. The helium slowly coming out of solution may have been the source of the pressure rise in the manifold rather than a leaking manifold isolation valve. Once the fire started, it heated the area thus increasing the pressure and pushing additional fuel out of the fuel feedline that was trapped. In both scenarios (leaking manifold isolation valve or helium coming out of solution), liquid MMH was present in the manifold line just prior to and during the fire and the manifold pressure increase went unnoticed.

The “official” cause of the ignition from the mishap report was stated to be electrostatic discharge passed from the materials (Orcofilm being one of them) used for spill protection to the SCAPE suits, gloves, and tools. The spill protection materials and SCAPE suit failed electrostatic testing performed following the mishap. Another possible cause for ignition (not put forth by the mishap report) was a decomposition combustion reaction of the MMH and a material that it contacted. A hypergolic reaction with the  $N_2O_4$  ( $NO_2$ ) vapors that were possibly leaking from a nearby double-bagged oxidizer feedline dynatube was not a likely source of ignition since the aspirator was positioned directly adjacent to the open end of the oxidizer feedline. An atmosphere of approximately 10%  $N_2O_4$  ( $NO_2$ ) vapors is needed for a hypergolic reaction with MMH vapors in air. With the amount of atmosphere that the aspirator was drawing in and the fact that the feedline was not receiving a constant pressurized source of  $N_2O_4$ , obtaining a 10% atmosphere of  $N_2O_4$  ( $NO_2$ ) vapors was not possible.

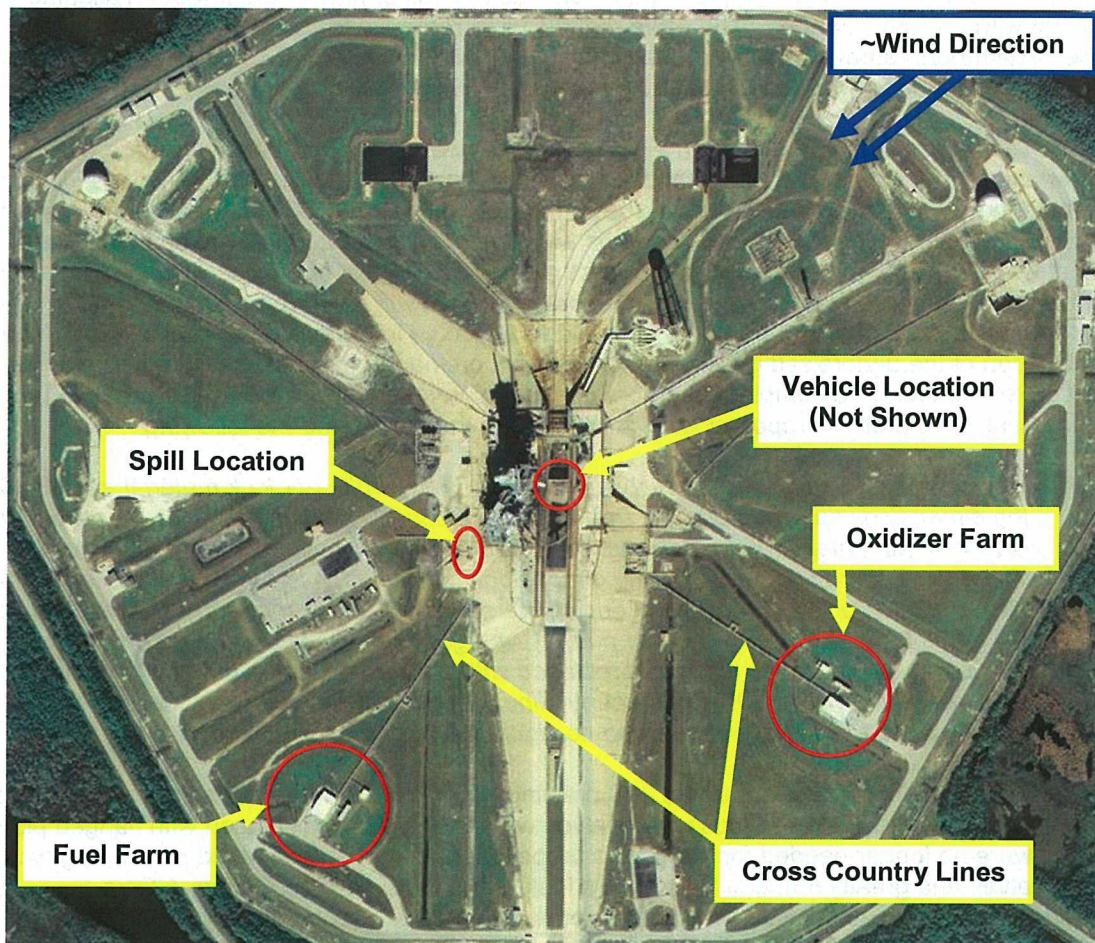
Figure 42: Geographic Layout of Launch Pad 39B

During the  $N_2O_4$  GSE drain down following OV-102’s oxidizer servicing, the cross-over valves were closed. A water hammer effect from the liquid column in the GSE lines opened a gap at the cross-over valve flanges (inlet and outlet). This gap enabled liquid oxidizer to leak out onto the launch pad slope (the concrete incline from ground level to the base of the launch tower).

The SCAPE van driver was the first to detect the spill when he smelled oxidizer in the area of the fuel farm (see Figure 42 for a geographic layout of Pad 39B). Safety officials at the launch pad perimeter noted the source of the oxidizer vapors was the Pad 39B west slope. Three technicians in SCAPE were directed to proceed to the general area of the vapor source from their location on launch pad tower 107-foot level. Upon arrival, the technicians noted that heavy  $N_2O_4$  ( $NO_2$ ) vapors were leaking from both the inlet and outlet flanges of the return cross-over valve. They also noted that there were still several gallons of liquid  $N_2O_4$  on the ground near the flanges and at the bottom of the slope in a grassy area. Sparks were seen shortly after the arrival of the technicians; therefore, two of the three evacuated. Some of the liquid  $N_2O_4$  that had flowed down the slope incline contacted the electrical conduits routed along the ground that supplied power to nearby lighting. The technicians were unaware that the  $N_2O_4$  had dissolved some of the cabling insulation.

Following this incident, the Pad 39B drawings were updated to require the installation of the proper flange seals. All the cross-over valves were removed and replaced with flanged pipe as they were no longer needed for hypergolic propellant loading. This reduced processing time on the valves and greatly reduced the risk of a leak at the valve flanges. Figure 43 is a photograph of the location where the cross-over valve complex was previously located at Pad 39B and Figure 44 is a photograph of the location of the Pad 39B fuel cross-over valve complex with the fuel farm and Vehicle Assembly Building in the background.

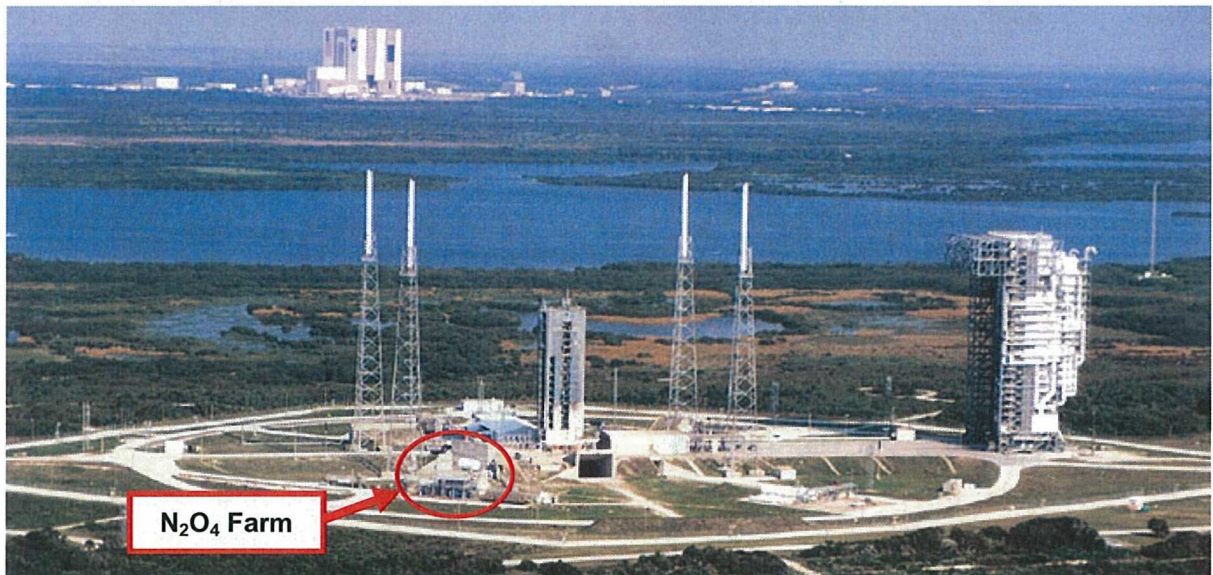
**Figure 47: LC-40 at CCAFS**

On August 12, 2003, at CCAFS launch Pad LC-40 (shown in Figure 47) during the bleed-in operation for the B36 Stage II (Titan IV) propellant load, the oxidizer centrifugal pump exploded (proximate cause of the N<sub>2</sub>O<sub>4</sub> spill). The Titan IV launch vehicle was being loaded in preparation for the September 9, 2003 launch of the National Reconnaissance Office's payload. Along with the liquid N<sub>2</sub>O<sub>4</sub> release of approximately 40 gallons, the explosion created a large amount of shrapnel which caused significant damage to the surrounding GSE. The pump was completely destroyed as shown in Figure 48. Fourteen people reported to an on site health facility. They were all later released without injury. The storage tank holding several thousand gallons of liquid N<sub>2</sub>O<sub>4</sub> remained intact with minimal damage. An extensive investigation was initiated as a result of the Space Shuttle Program using these same pumps at Pads 39A and 39B (eight pumps in four locations) along with the Titan program which used them at LC-40.
